2010 Annual Inspection Report

Fritchie Marsh Restoration

State Project Number PO-06
Priority Project List 2

December 15, 2010
St. Tammany Parish

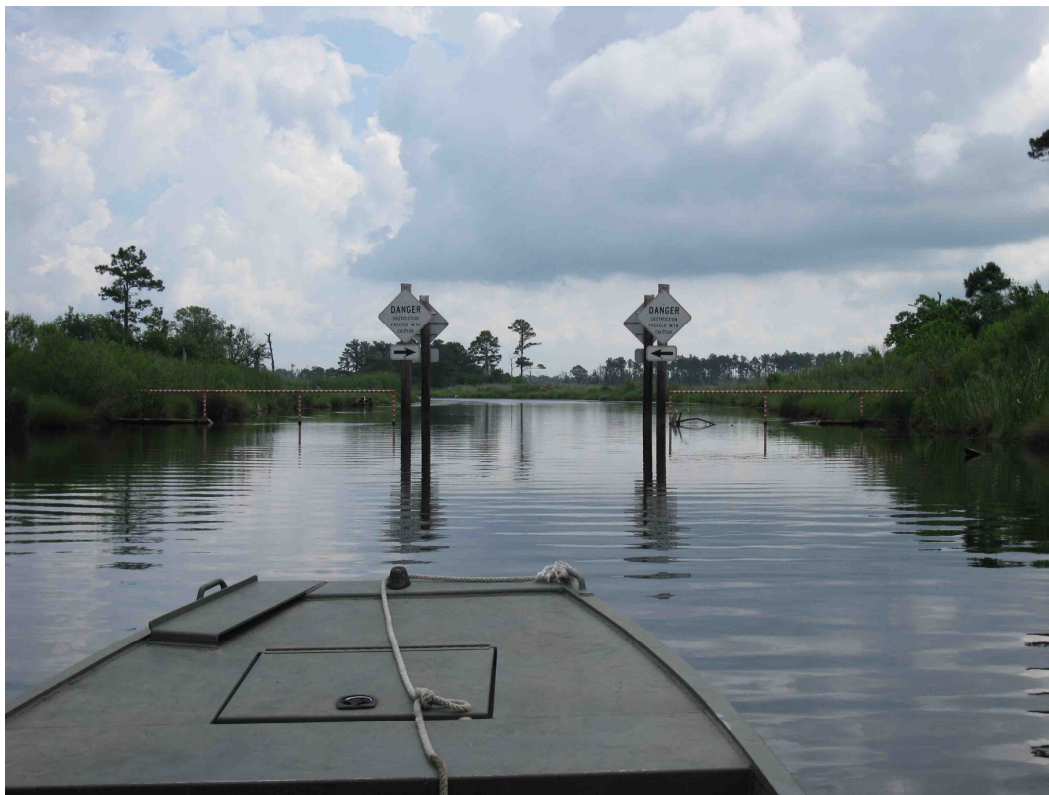
W-14 Weir

There was no visible damage to this structure and it appears to be operating as designed.

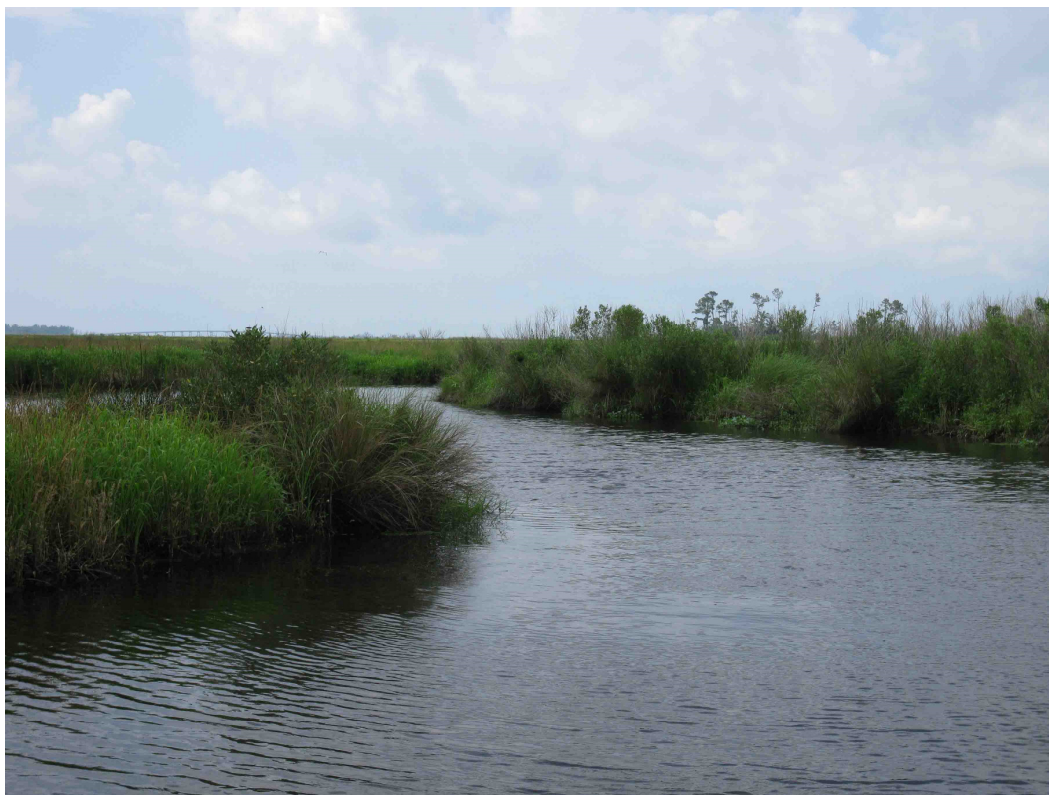
W-14 Diversion Channel Beyond Dredging

There is no damage to this feature. There is a sunken object in the mouth of this channel, but appears to be causing no interference in flow.

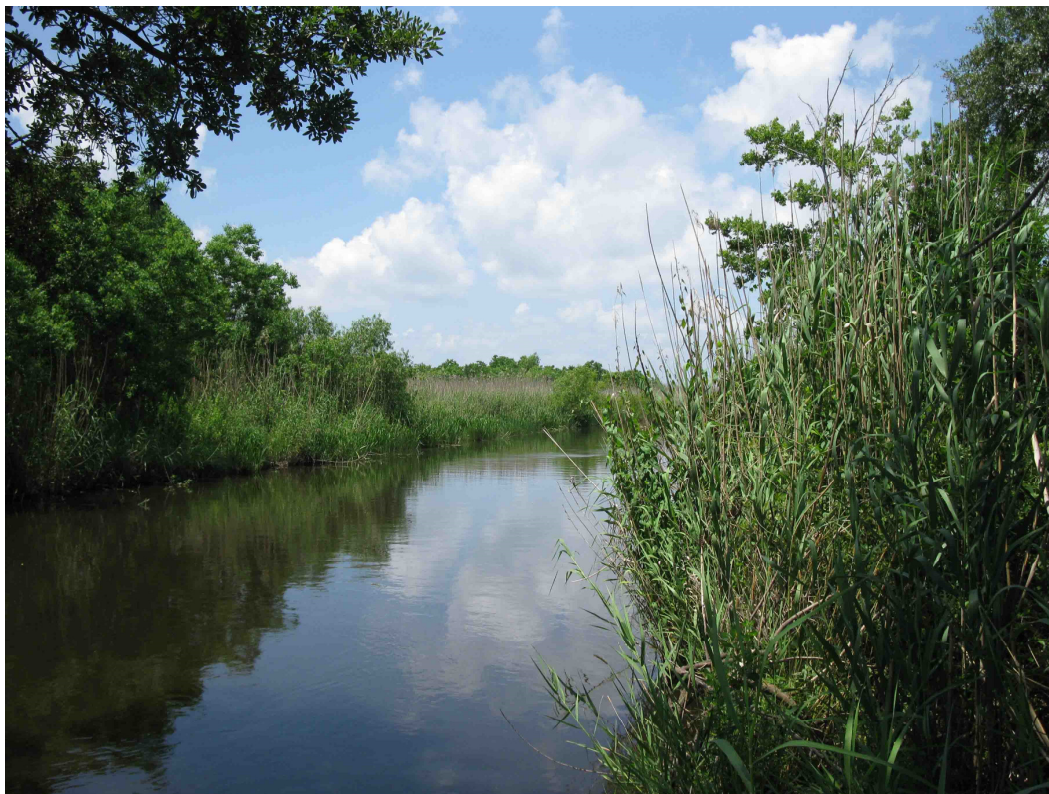
Salt Bayou from Culverts

There was not a detailed inspection performed of this feature. The inspection consisted of boat travel halfway down the bayou from the west and observations made from Hwy 90 at the culverts. There was no damage observed at the areas inspected. The worst sections from the previous inspection, where breaches and infilling occurred, were not inspected.

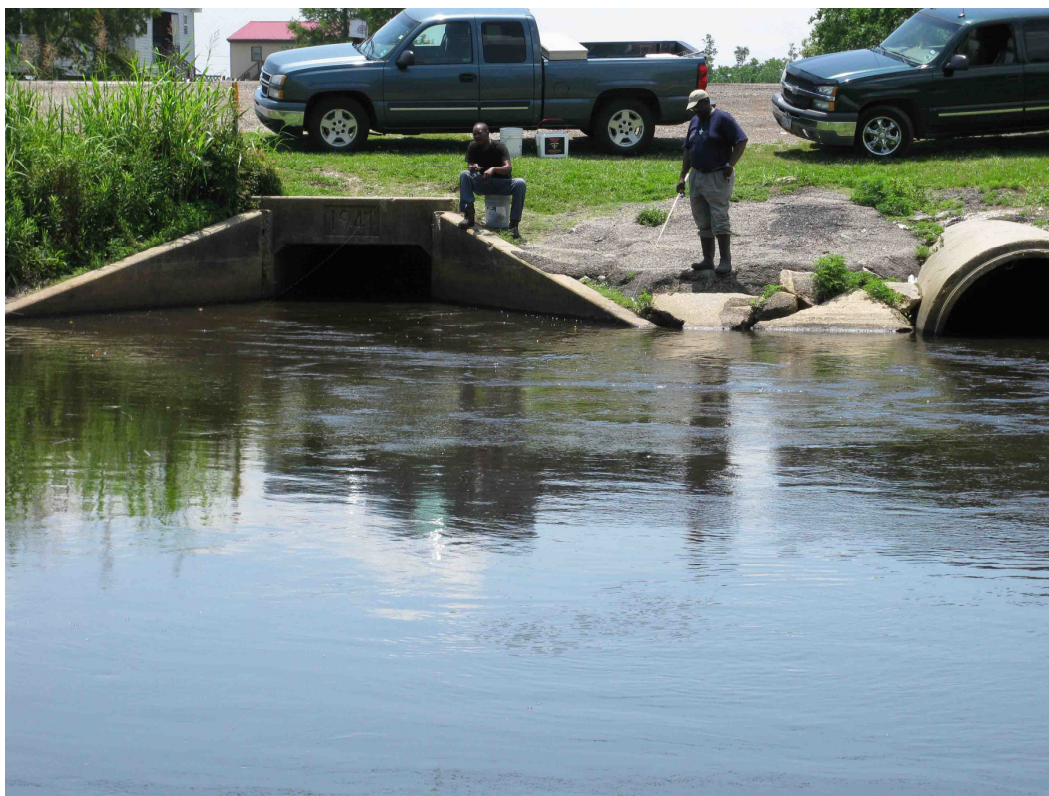
Culverts from Project Side

There is no change in this structure from the previous inspection. The bank scour reported in previous inspection reports is still of concern, however it is vegetating very nicely. If this bank were to completely breach, the hydrologic exchange between the marsh and Salt Bayou would be altered.
